PHASE I INSPECTION REPORT
NATIONAL DAM SAFETY PROGRAM
TRINITY DAM I.D. No. NY 129
DEC #232B-3370
LONG ISLAND RIVER BASIN
WESTCHESTER COUNTY, NEW YORK

Name of Dam: Trinity Dam (I.D. No. NY 129)
DEC # 2328-3370

Date of Inspection: September 7, 1978

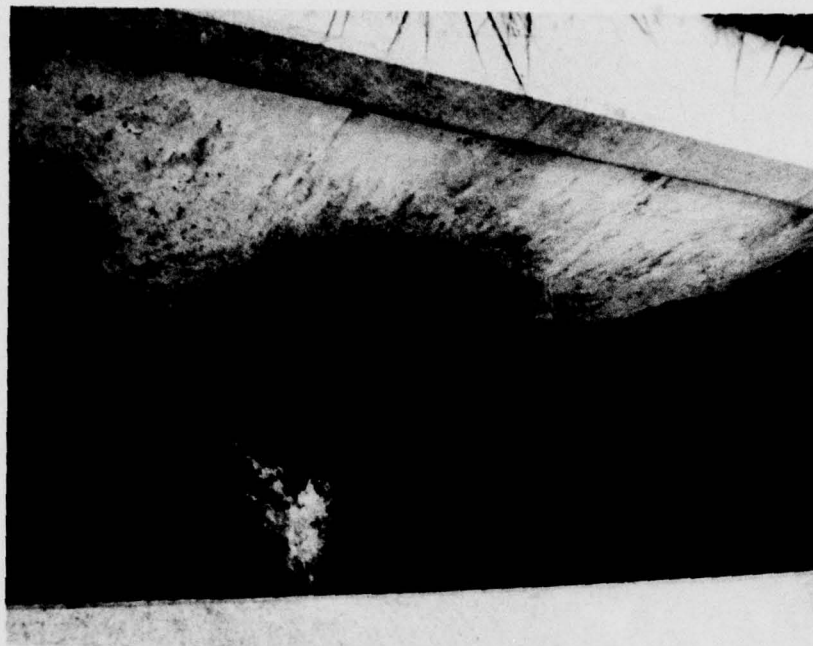
48" Reinforced Concrete Pipe in Impact Basin
and 8" vitrified Clay Pipe (Berm drain) in corner

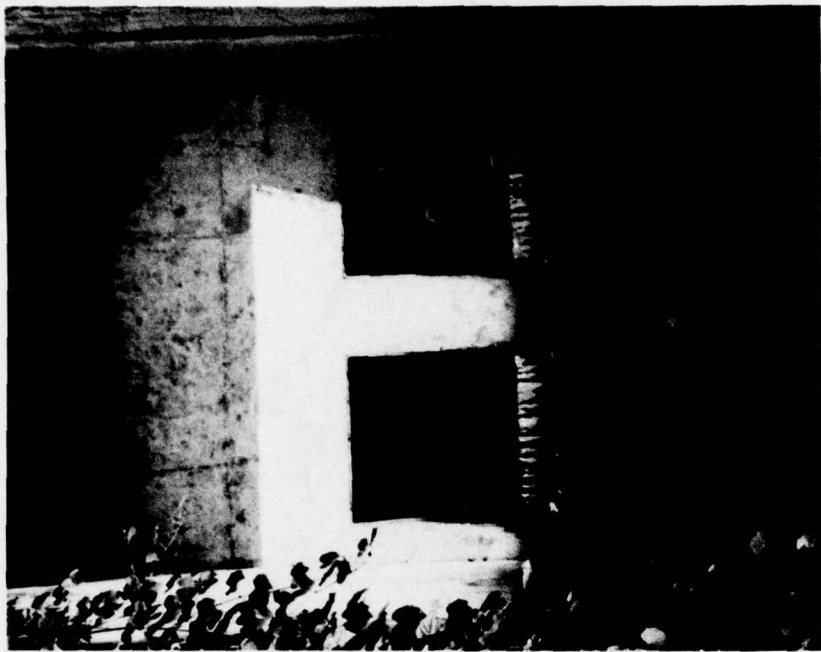
West Face of Saddle Dam
outlet to Trinity Lake

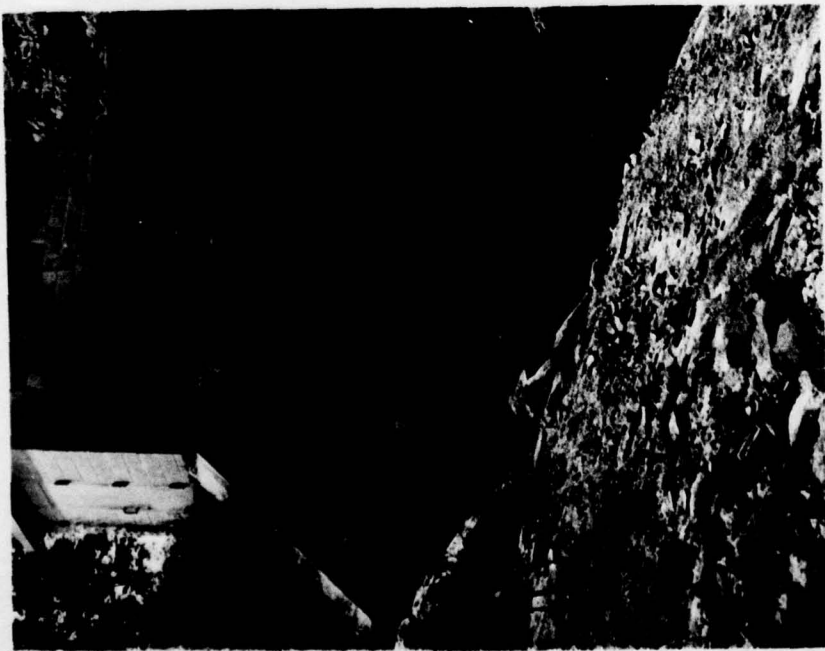
East Face of Saddle Dam
note sluice gates
